# Quality assessment of the PVC gas grid in the Netherlands

René Hermkens, 17 September 2019 Bologna

Kiwa Technology

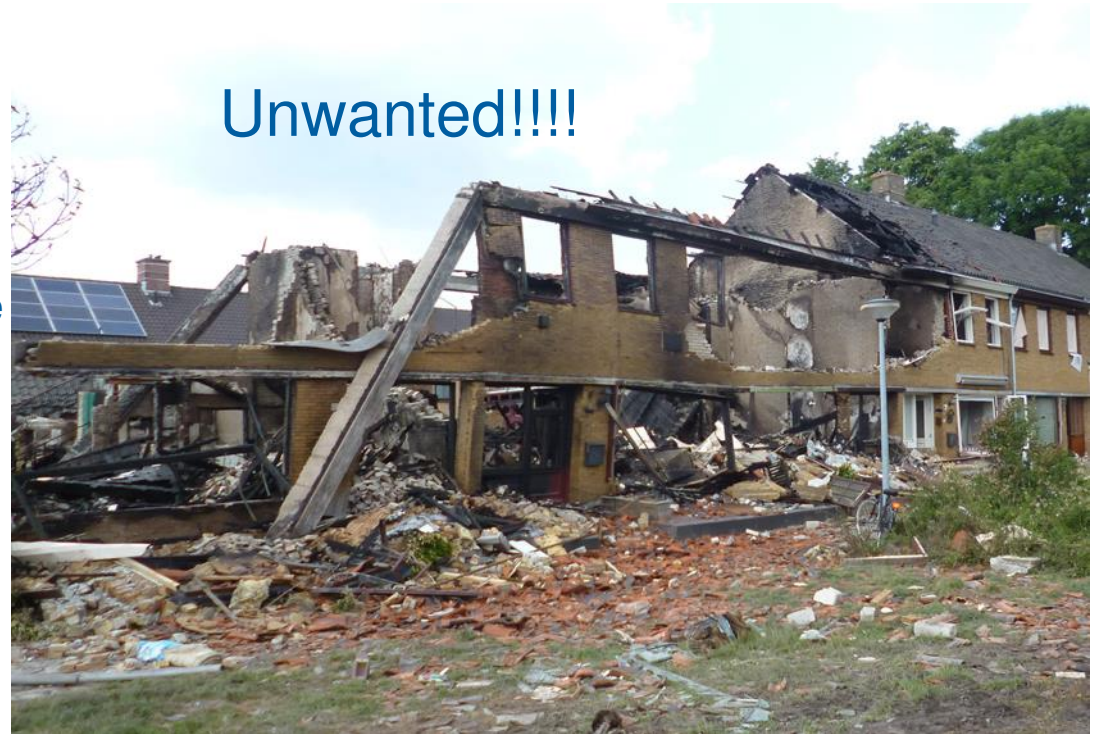
## Brittle failure:

- High gas outflow
  - No time to detect and repair leak
  - High chance of explosion or fire
- Repair difficult (sawing)

## Ductile failure:

- Limited to no gas outflow
  - Ability to detect and repair leak
  - Low chance of fire

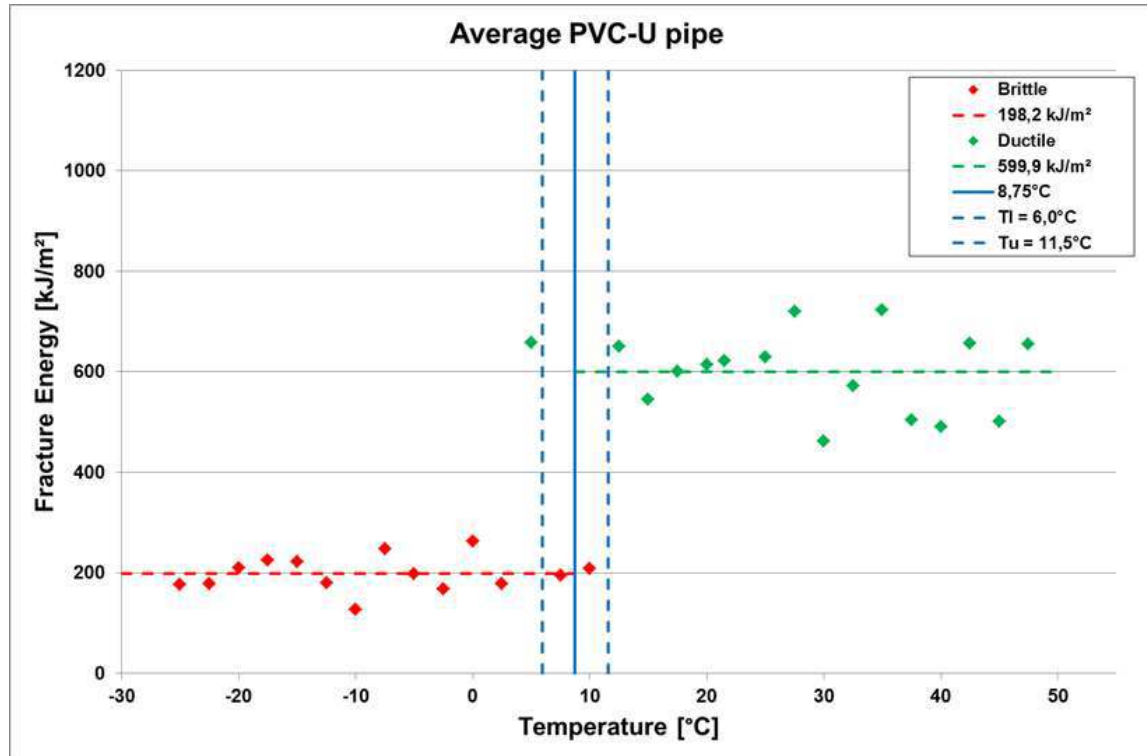
An average PVC-U pipe with a  $T_{BD}$  of 8,75°C

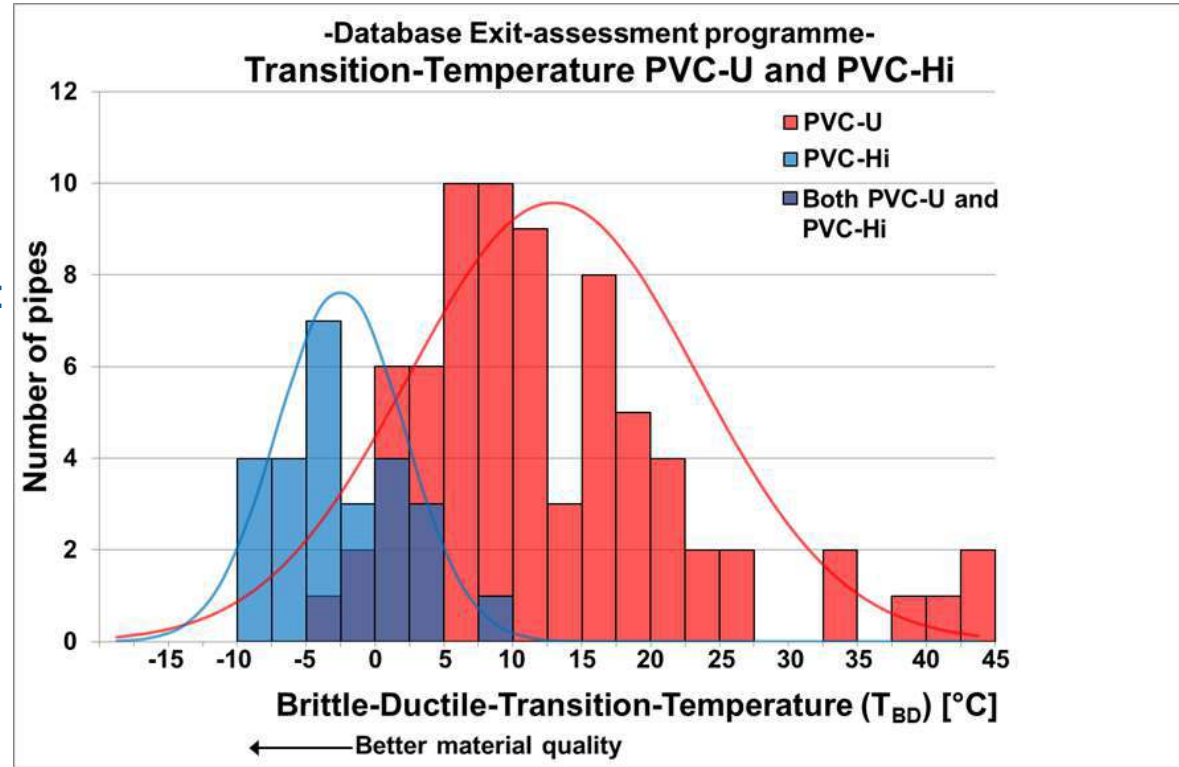
- Annually 15 samples of both PVC-U and PVC-Hi
- Additional information from distribution system operator on:
  - Installation date
  - Dept of installation
  - Type of installation
  - Ground water level
  - Et.cetera
