Towards an exit assessment program for PVC drinking water pipes

Added value of a failure registration database

Amitosh Dash, Karel van Laarhoven, Ralph Beuken

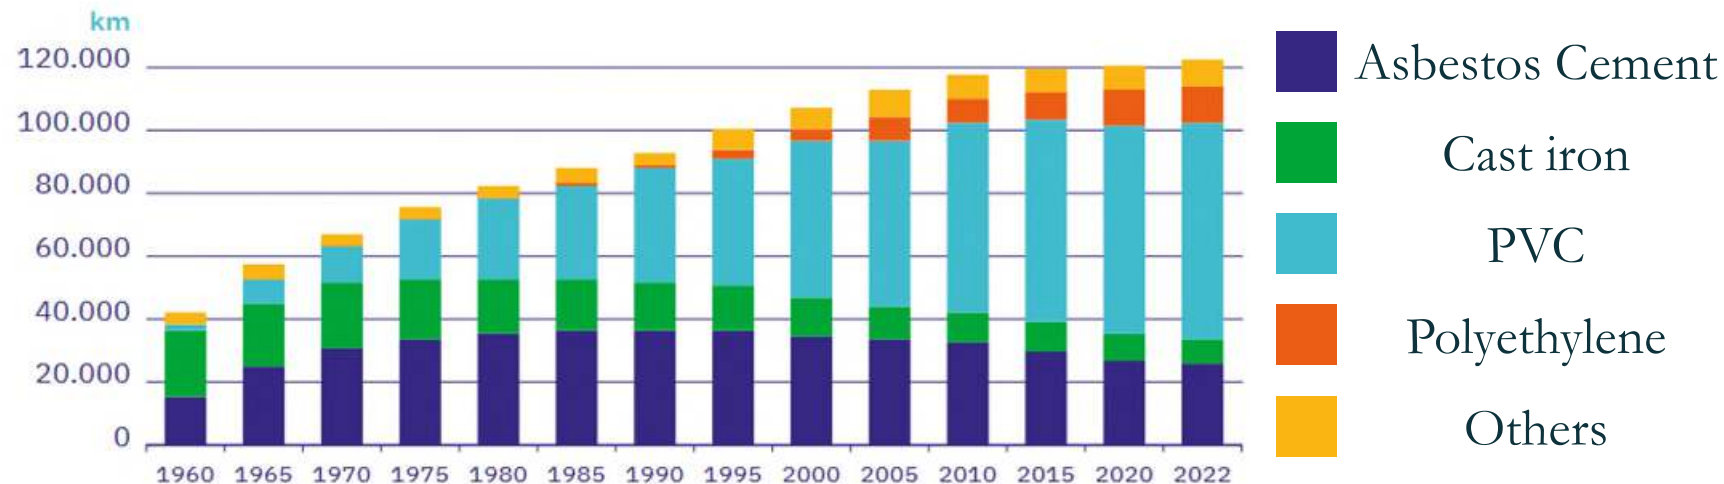
Conundrum: Which PVC pipes should be prioritized for replacement?

Replacing 600 km PVC (1%) in a year costs €150M!

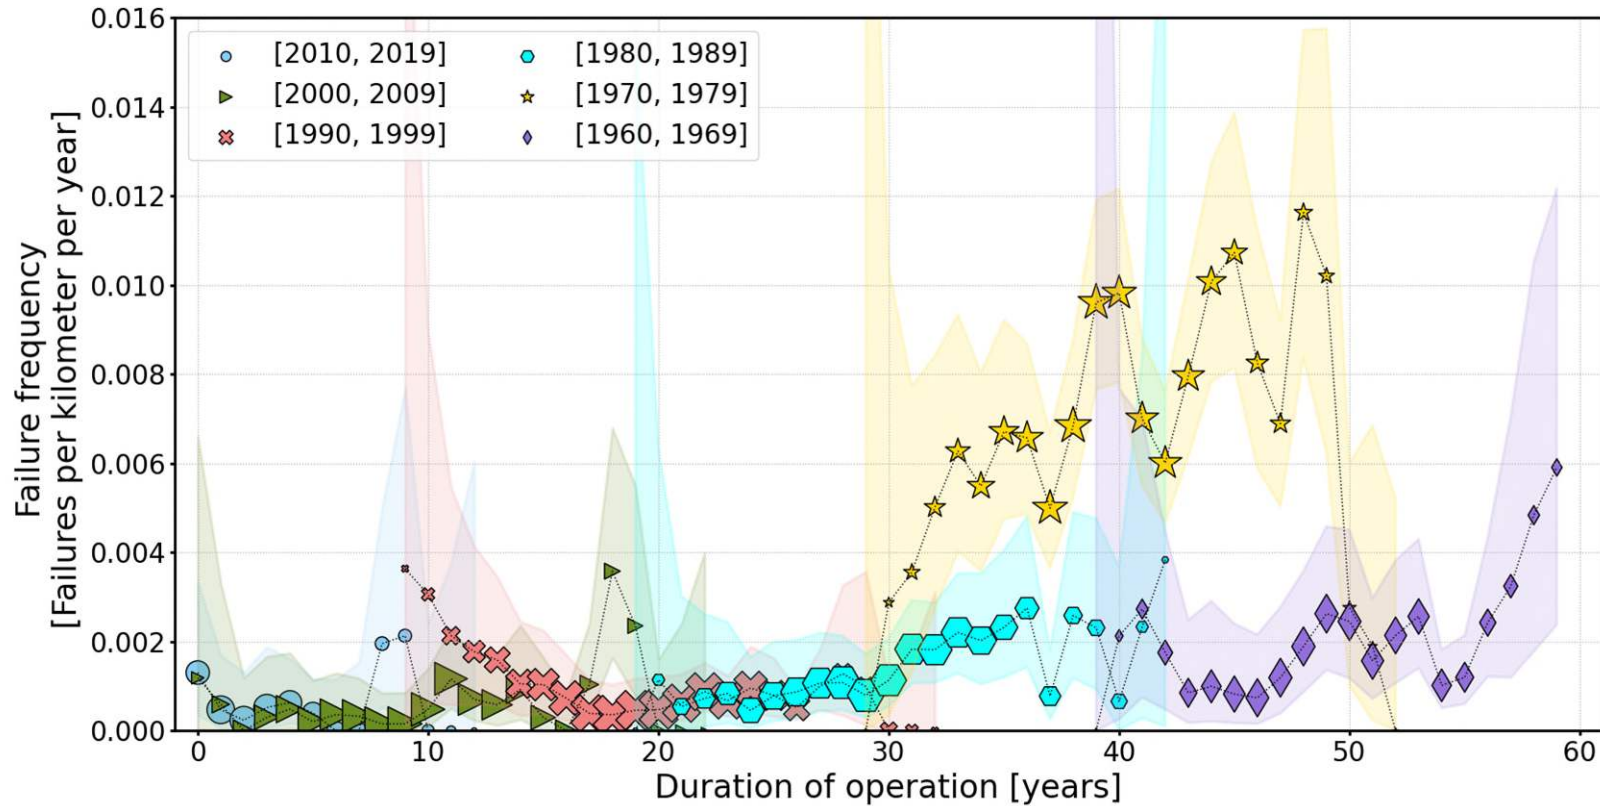
Reading the graph: For PVC pipes installed between years Z_1 and Z_2 , after X years of operation, there are Y failures per kilometer per year with a longitudinal crack

USTORE helps assess performance of various pipe groups

Possible explanation: PVC pipe production still maturing in 1970's (good and bad pipes produced)
Data reveals performance but not the causality
